Manhole Inspection Summary

Manhole # S47E__014MH

Insp Date: **7/28/08 9:14 AM**

Location Address: **Montford**

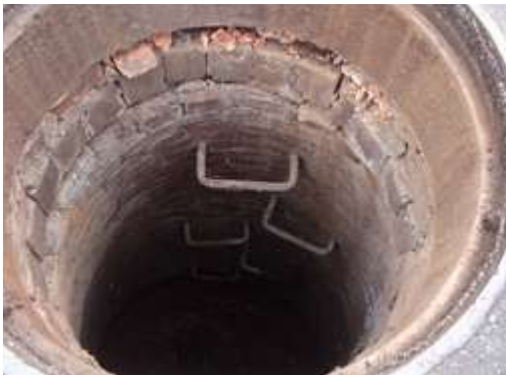
Defect 1

Condition: ☐ Sound ☐ Cracked ☐ Root Intrusion ☒ **Loose Brick** ☐ Deteriorated

Infiltration: ☐ None ☐ Joint ☐ Cracks ☒ **Mortar** ☐ Roots ☐ Wall

loose brick

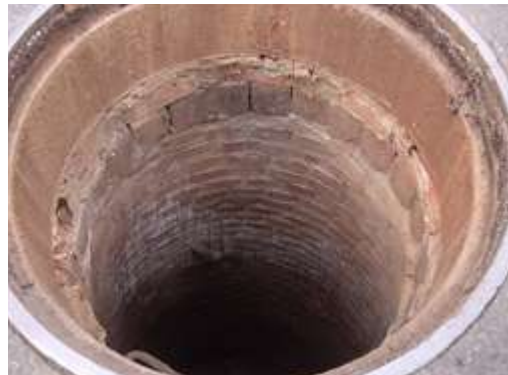
Defect 2

☒ **Leaks**

frame leaks

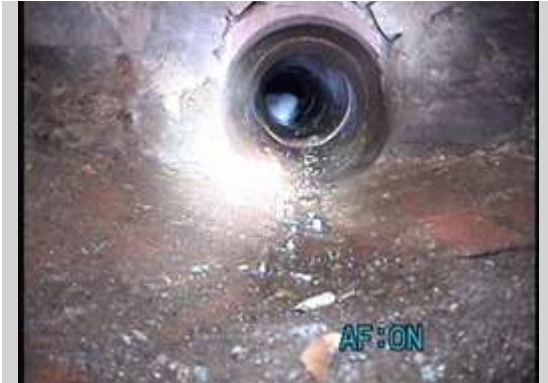
12 O'Clock Outflow

8 in. Circular Gravity Sewer
Pipe Out @ 12 O'Clock

Infiltration: **None** Pipe Seal Cond: **Sound**
